**“Joint Management of Urban Wetland Areas in border region Latvia-Lithuania”  
Urb-Area Nr.LLI-472**

## **DAUGAVPILS AND ANYKŠČIAI URBAN WETLANDS MANAGEMENT PLAN**

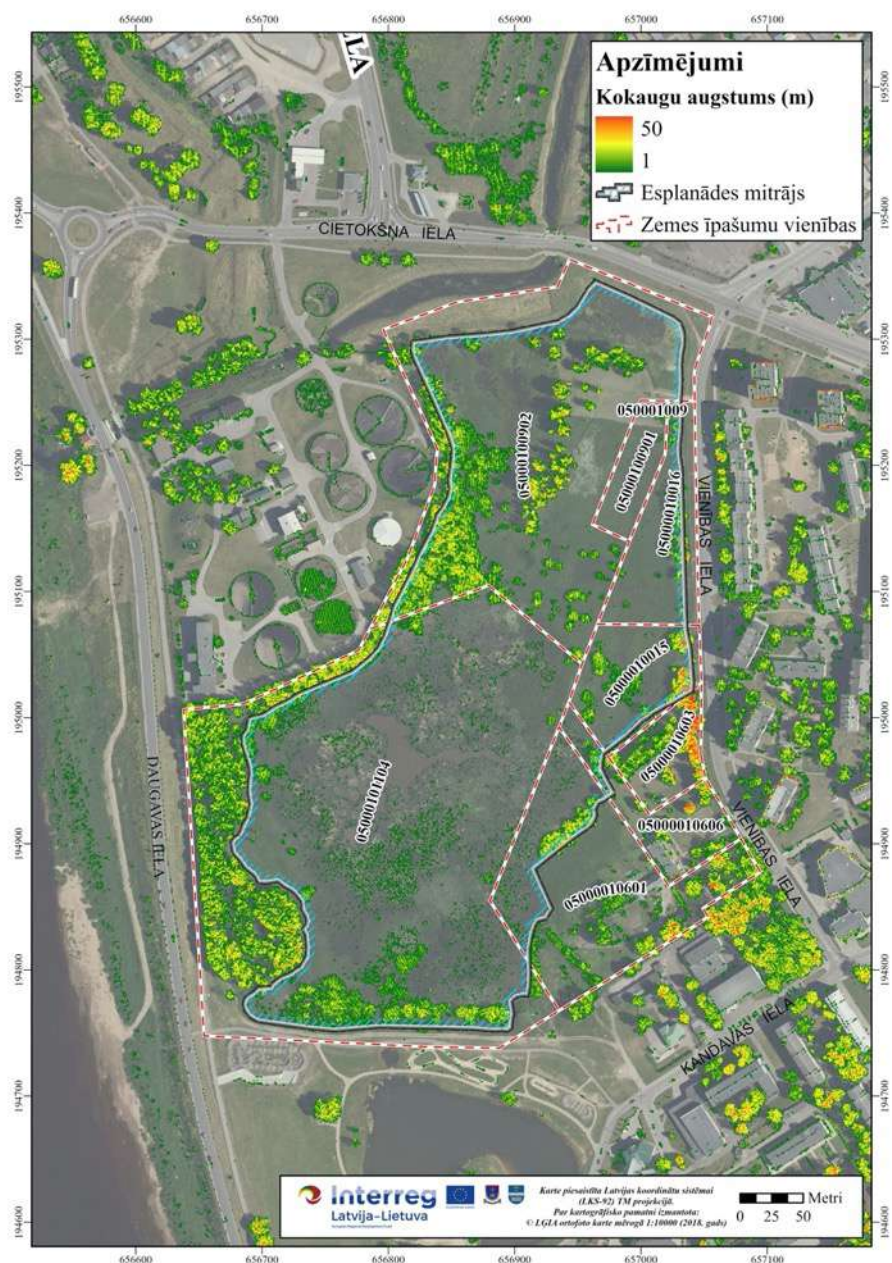
Figure 15. *LIDAR vegetation surface model*

The Esplanade Wetland is one of the lowest areas of the city, surrounded by man-made embankments and dykes. The Wetland is covered by aquatic and wet-loving plants in the lower areas and low-demanding native and invasive tree species in the higher and therefore drier areas. Native species are mainly deciduous woody plants - willows, maples, aspen, birches, etc. Invasive species - dogwoods, ashleaf maples. The Wetland vegetation is mainly formed by the highest woody vegetation along the perimeter, which partially reduces the visual accessibility of the site. The N part of the site consists of a wider tree cover - mainly willows, birches, maples and a planted group of larches. See Figure 15 for the LIDAR vegetation cover pattern.

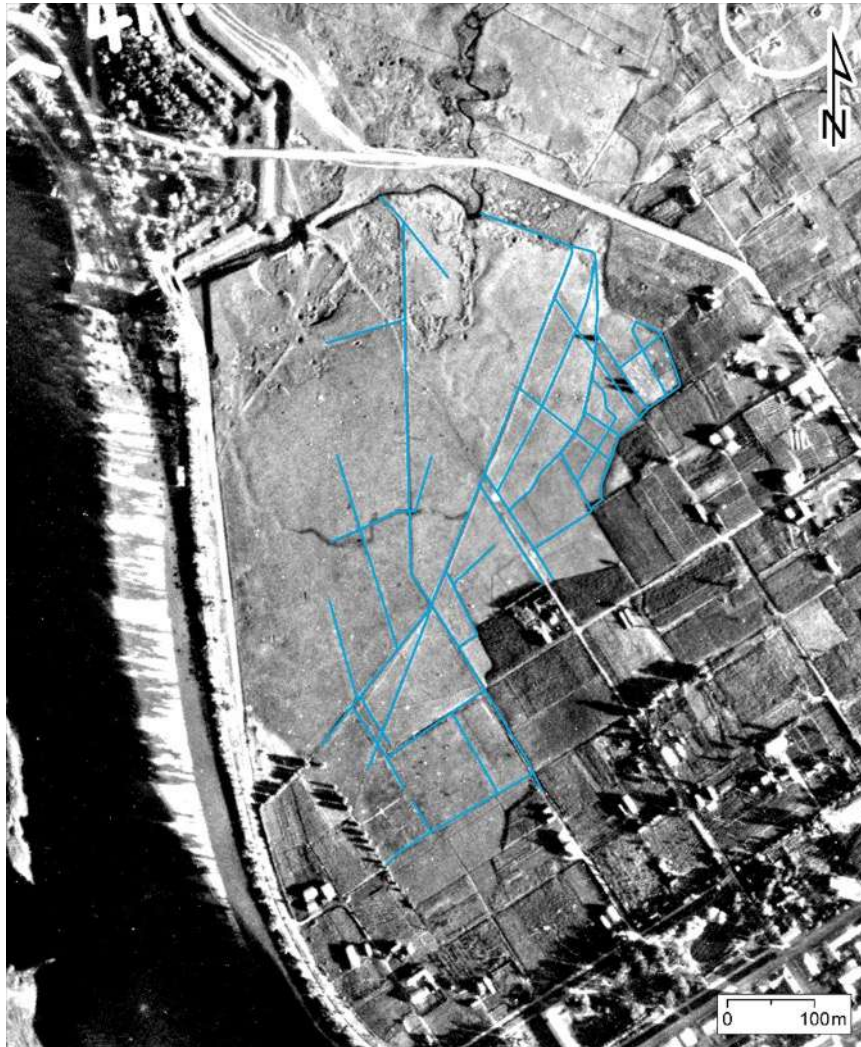
*Figure 32 Luftwaffe (Nazi German Air Force) vertical aerial reconnaissance photograph taken in 1944 - with blue lines indicating the location of drainage ditches*

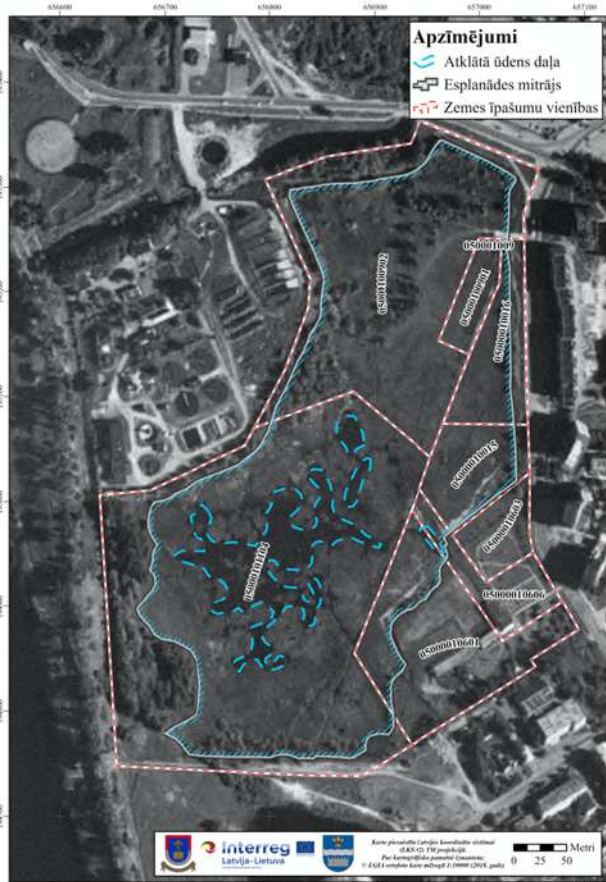
Figure 33. Open water fraction in the Wetland in 1995

Comparing the 1995 and 2017 data (Figures 33 and 34), the open water area of the water body within the Wetland has decreased by 78%, therefore, to maintain the hydrological regime, a water level regulation system is needed to ensure that the water level in the Wetland is stabilised and the surrounding areas are not flooded. This in turn would bring the Wetland closer to its natural runoff regime.

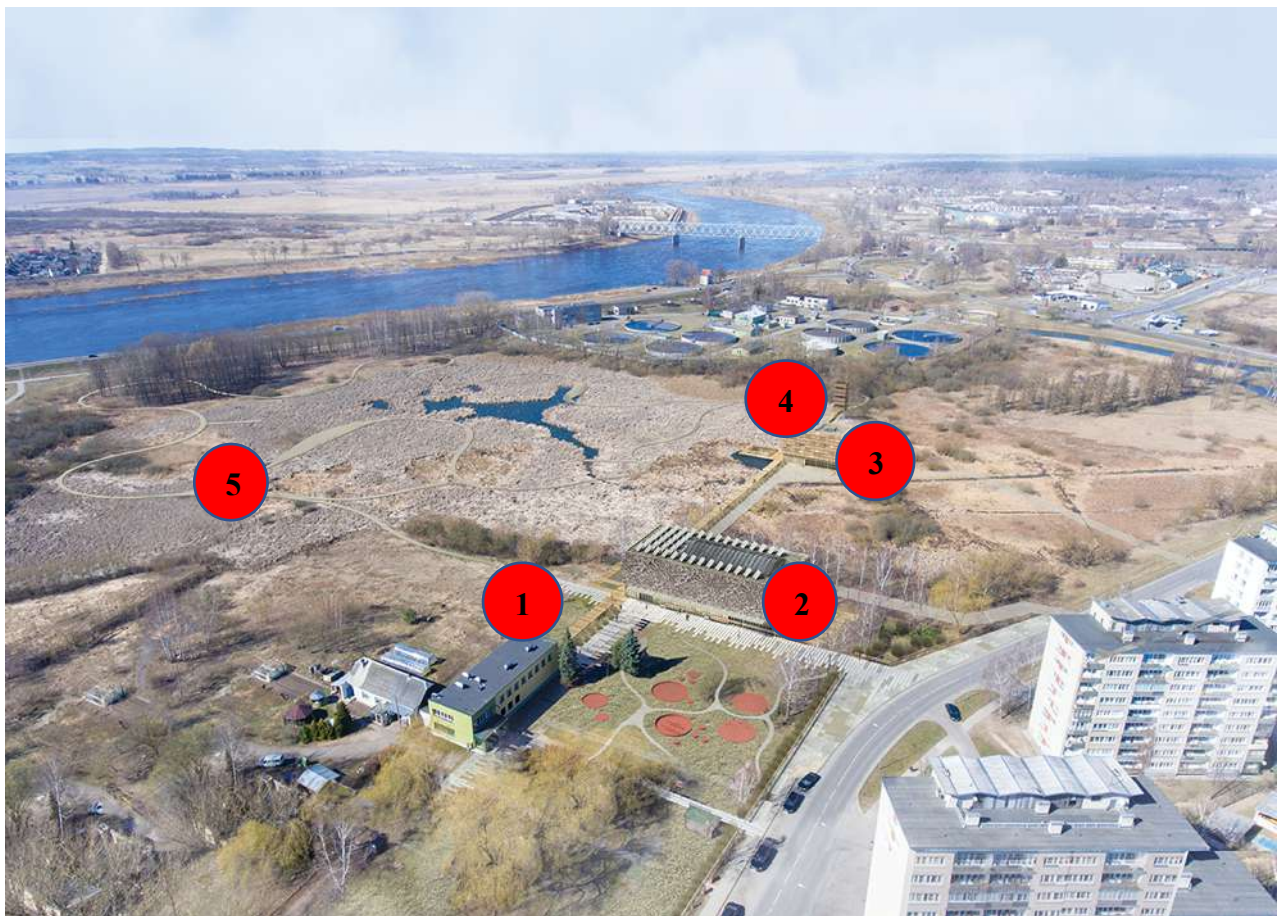
*Figure 45. Location of planned tourist and nature education objects in the territory of Esplanade Wetland (1 - existing building of Latgale Zoo, 2 - planned Jungle House, 3 - planned Swamp House building, 4 - planned viewing tower; 5 - planned trail route (image from the design prepared by "Trīs arhitektūra" and "Sudraba arhitektūra")*

The architects of the "Swamp Footbridge" project propose to create a swamp footbridge system with one central footbridge connecting the existing zoo building complex with the new buildings - the Jungle House, the Swamp House and the proposed viewing tower (Figures 45, 46 and 47).

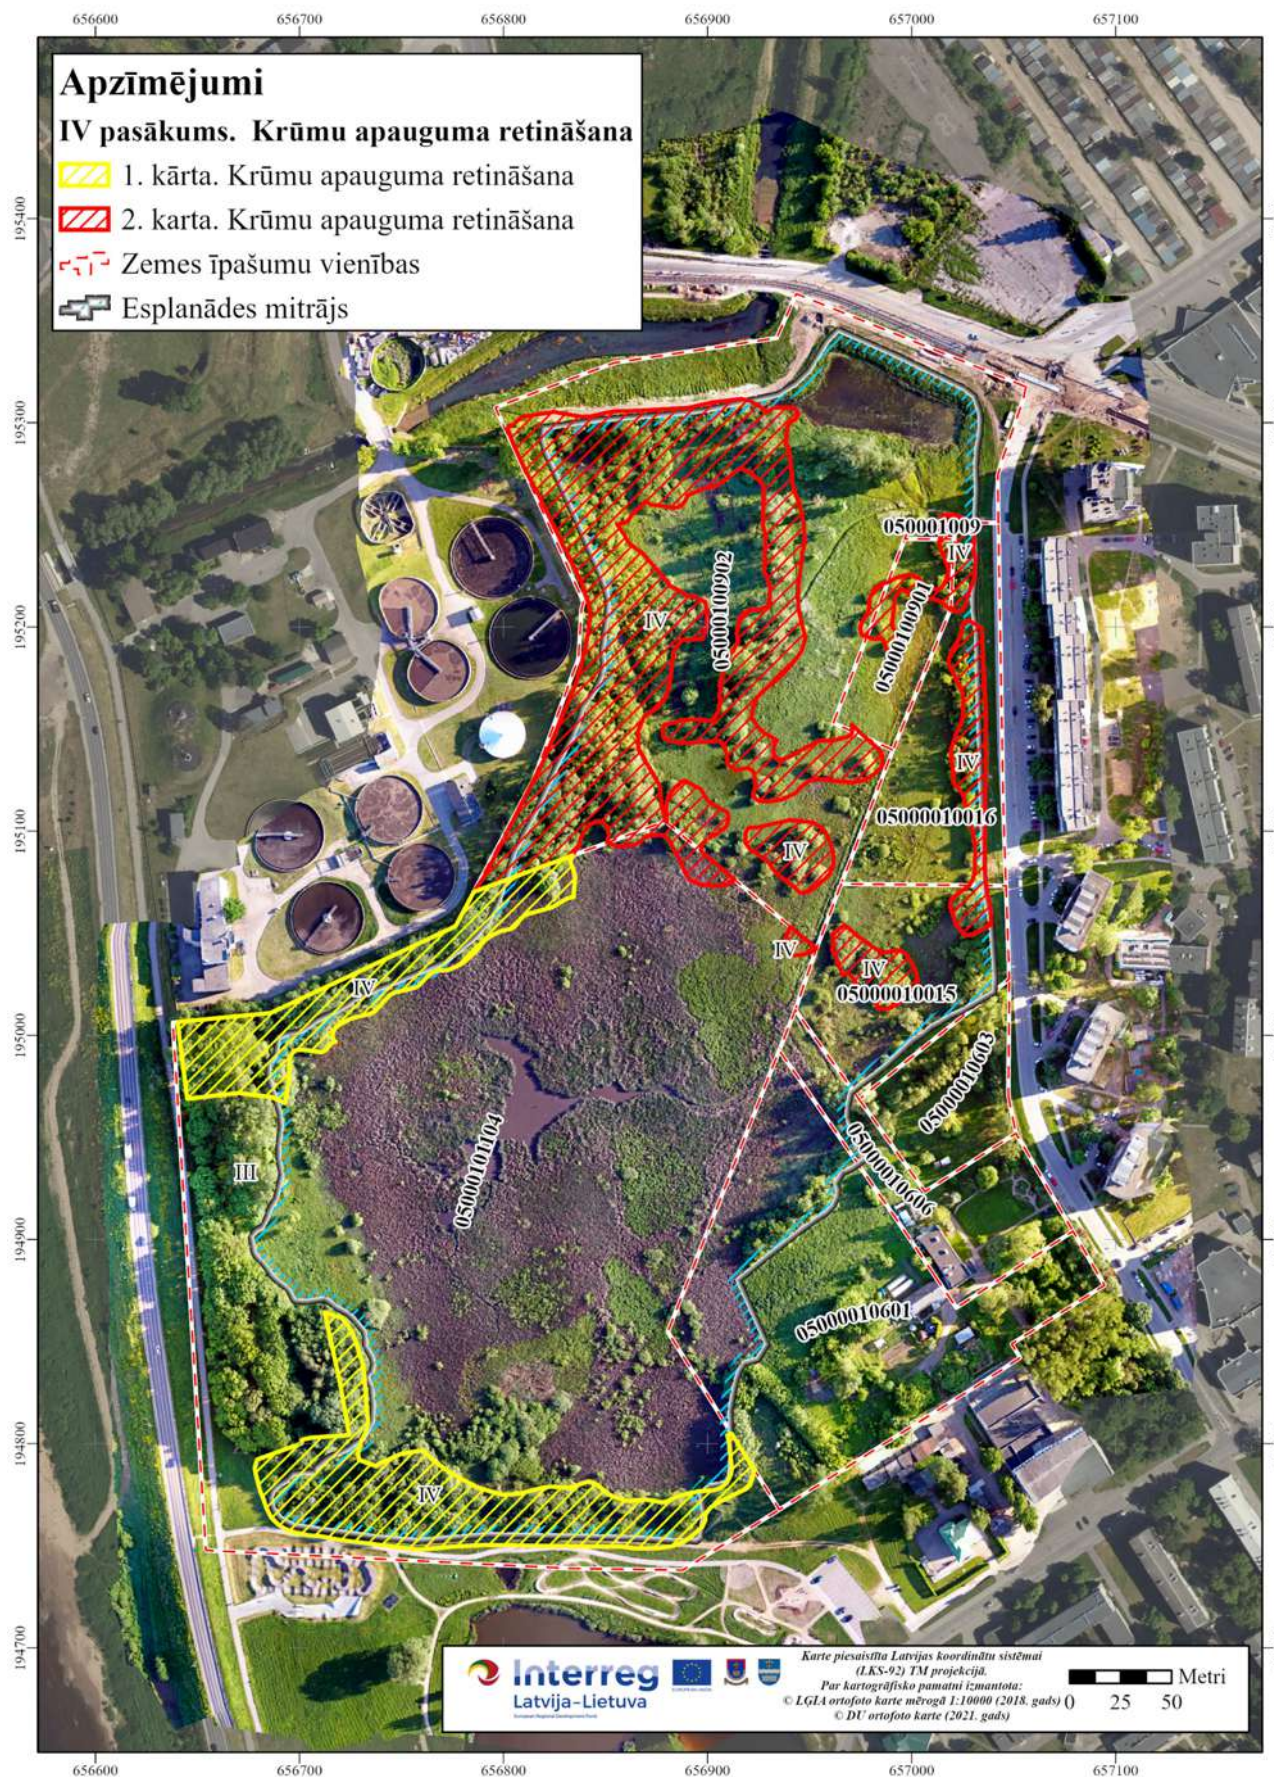
Figure 59. Sites of shrub thinning planned for Phase 1 and Phase 2

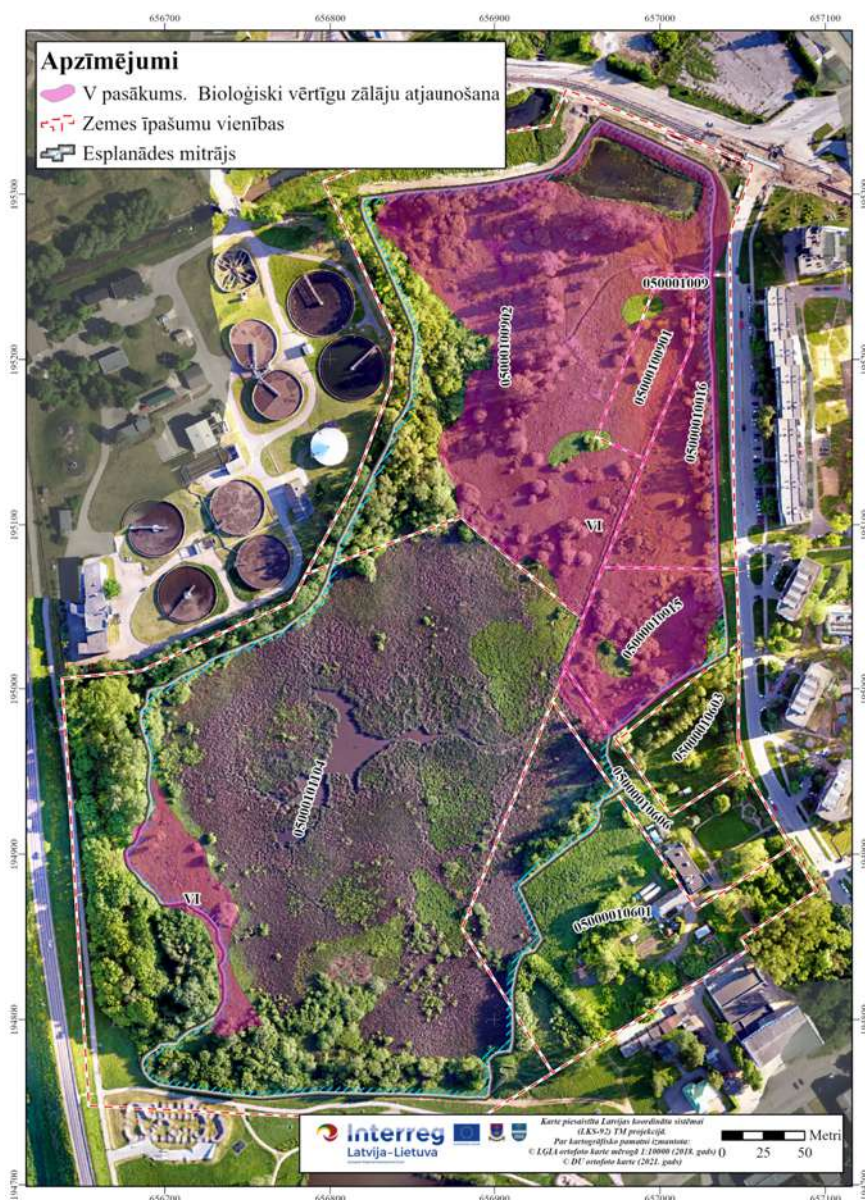
Figure 62. Areas where management of biologically valuable grasslands is recommended

The site of the existing Esplanade Wetland and the adjacent area have been reclaimed grassland (Figures 60 and 61), where hay mowing has taken place. At the moment, these are species-poor grasslands, but with a high regeneration potential. Areas where management of biologically valuable grasslands is recommended are shown in Figure 62. The total area under management is 5,8 ha.

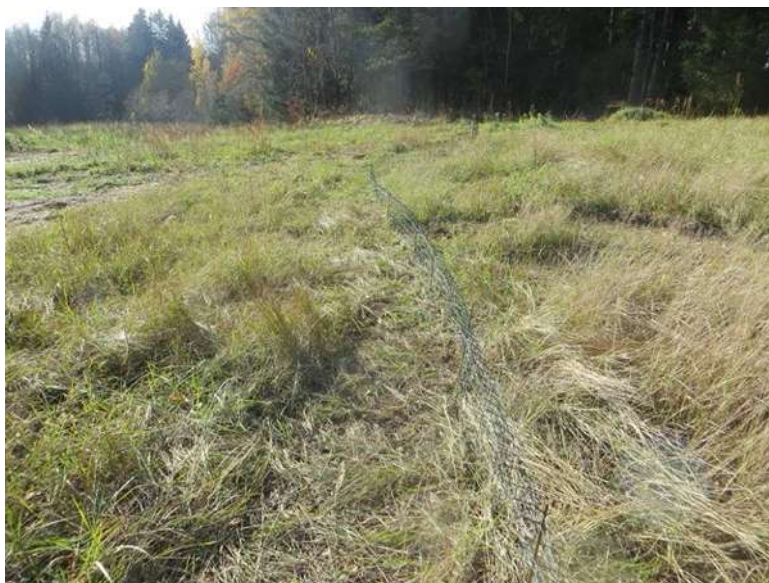
*Figure 63. Example of a fence - an example from the adjacent area of the amphibian breeding ponds created in the vicinity of the DU Study and Research Centre "Ilgas" (Photo: M. Pupiņš)*

The creation of a small fence is recommended to prevent juvenile birds and the European pond turtle (whose population is to be restored) from entering the roads. The installation of the fence is planned in two sections (Figure 64) - along Cietokšņa and Vienības Streets (approximately 430 m) and along the P67 road (approximately 260 m). Material of the fence: galvanised mesh painted green (Figure 63), mesh 5x5 cm, height of the fence 50 cm, of which 10 cm are buried in the ground and 40 cm above the ground, the upper 10 cm of which are bent inwards at an angle of 45-90°; the fence is supported by metal posts at intervals of ~ 1.5-2 m (depending on the micro-relief).

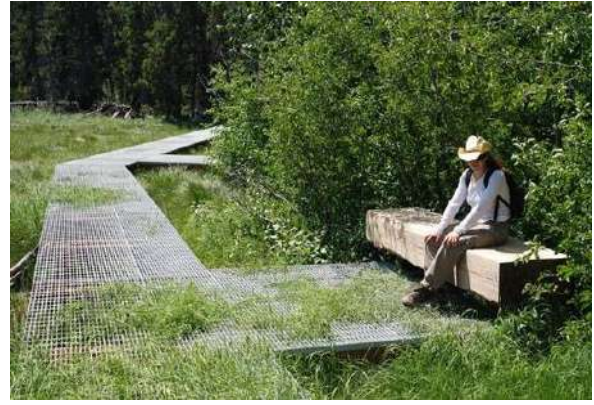
Figure 93. *Example of a raised galvanised steel lattice walkway with seating benches*

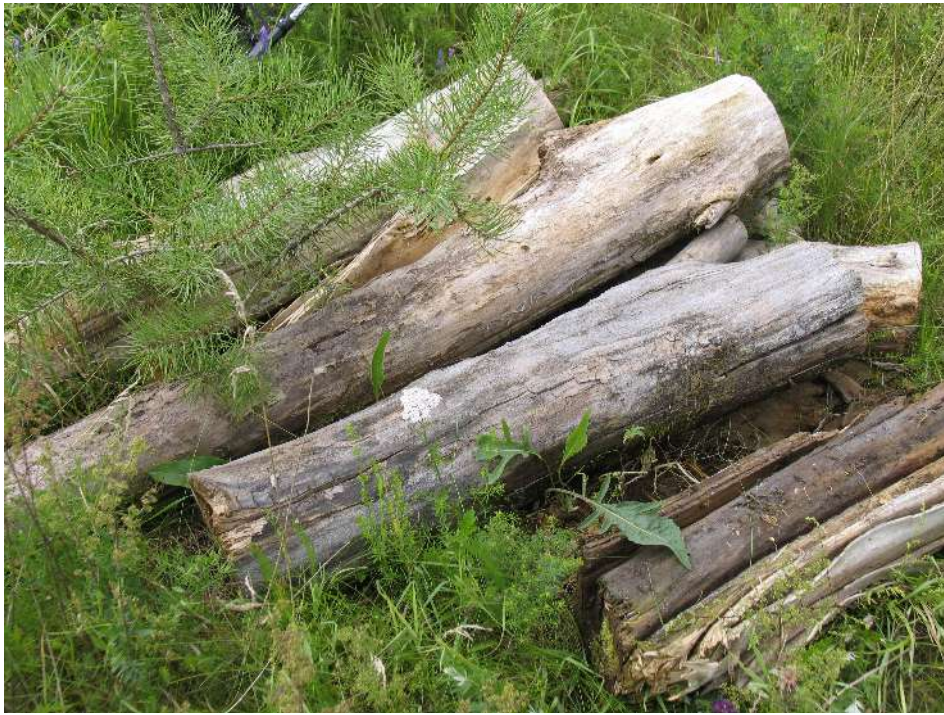
*Figure 117. Simple but effective: an artificial shelter for amphibians (Photo: J. Rimšaitė)*

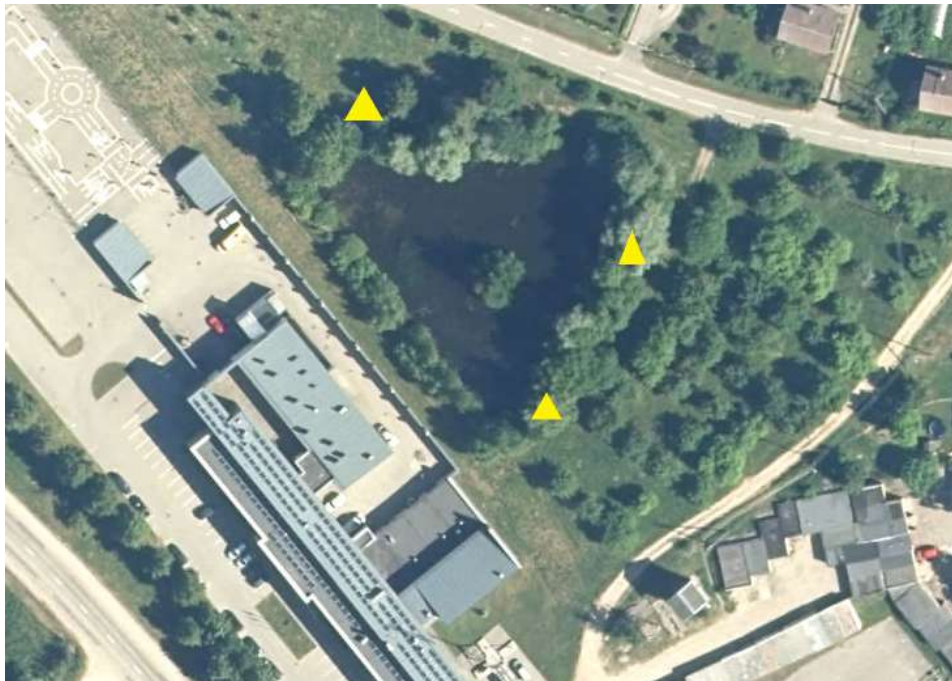
*Figure 118. Approximate locations of artificial shelters (Basic orthophoto map from [www.geoportal.lt](http://www.geoportal.lt))*
